# Manhole Inspection Summary

Manhole # S31GG\_026MH

Insp Date: **1/18/07 11:08 AM**

**Location** Address: **150 LANVALE ST**

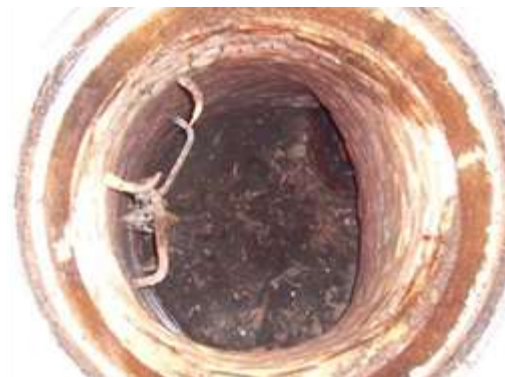
Top View

Corroded and missing steps. Evidence of surcharge - Bench debris.

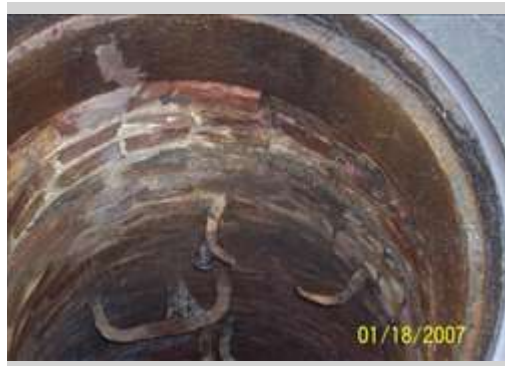
Defect

Frame leaks. Adjustment deterioration and infiltration. Corbel and Barrel infiltration.

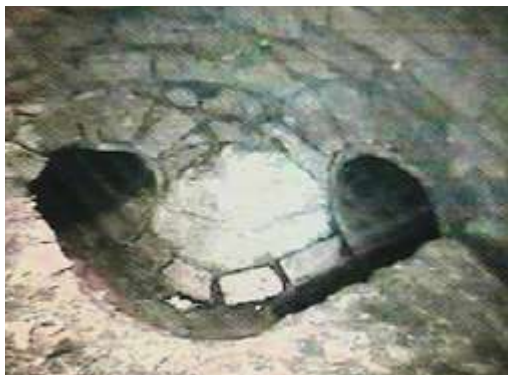
Defect

Barrel deterioration and infiltration. Channel debris.

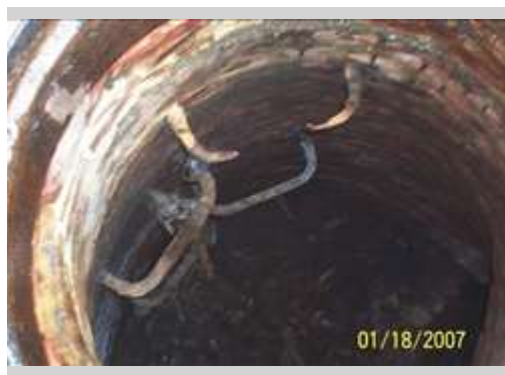
Defect

Frame leaks. Adjustment deterioration and infiltration. Corbel and Barrel infiltration.

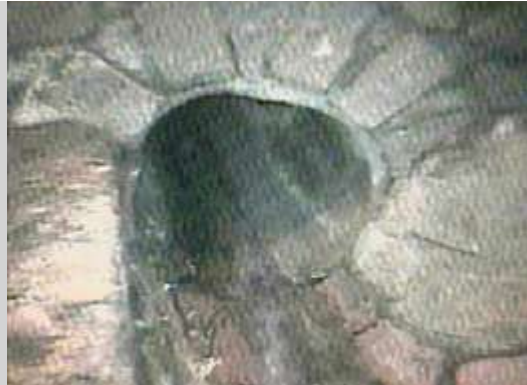
### 8 in. Circular Gravity Sewer Pipe Out @ 12 O'Clock

Barrel deterioration and infiltration. Channel deterioration.

Infiltration: **Evidence** Pipe Seal Cond: **Cracked**

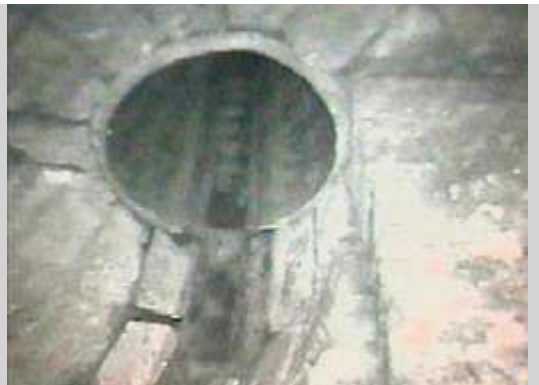
### 8 in. Circular Gravity Sewer Pipe In @ 3 O'Clock

Infiltration: **Evidence** Pipe Seal Cond: **Unknown**
